**APPLICATION FOR HERITAGE GRANTS FUNDING ASSISTANCE FALL 2017**

**HISTORIC PROPERTY AND ADDRESS:** 708 San Antonio, Austin, Texas 78701

**APPLICANT'S NAME:** Austin Woman's Club

**PROJECT NAME:** Windows Restoration of North-Evans Chateau Fall 2017

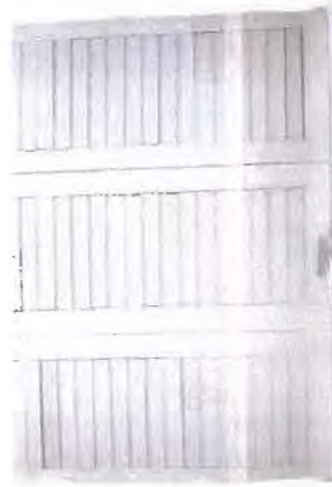
Photo 7: Typical example of failing bottom rail of top sash. Rail is bowing and dropping.

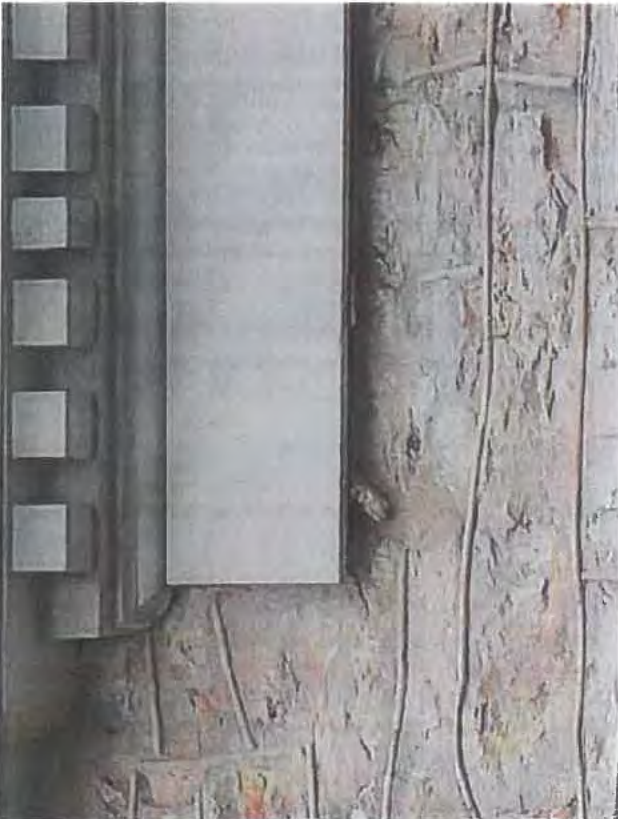
Photo 25: Detail of displaced frieze at east elevation. Note mortar fragment.

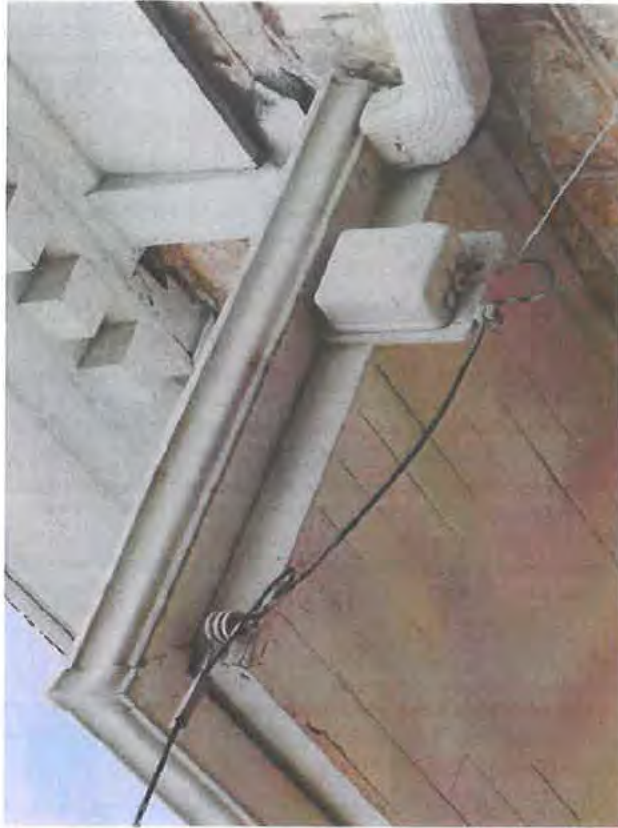
Photo 26: Detail of cornice and balcony roof at south elevation. Note open joints and discoloration, peeling paint, and displaced frieze.

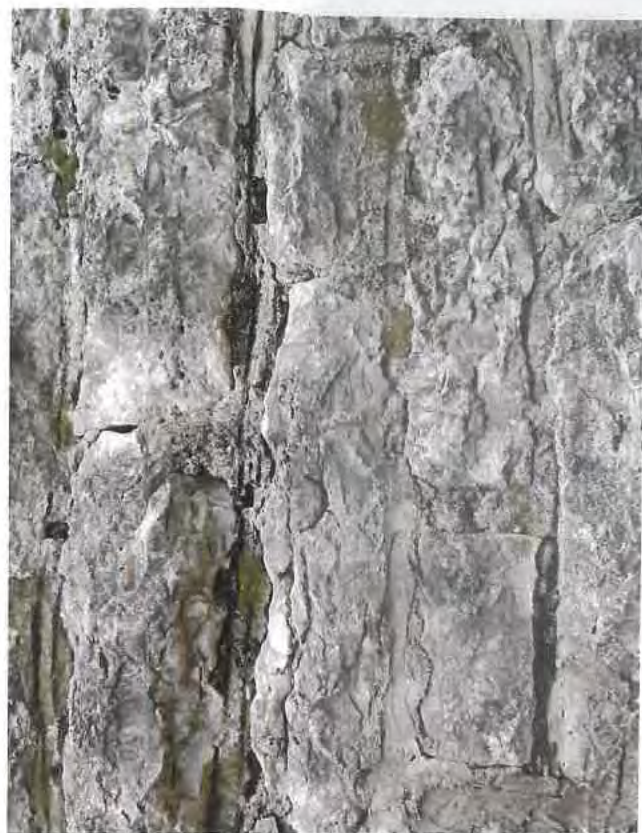
Photo 38: Example of voids in mortar, mortar separating from stone, and biological growths on stone.

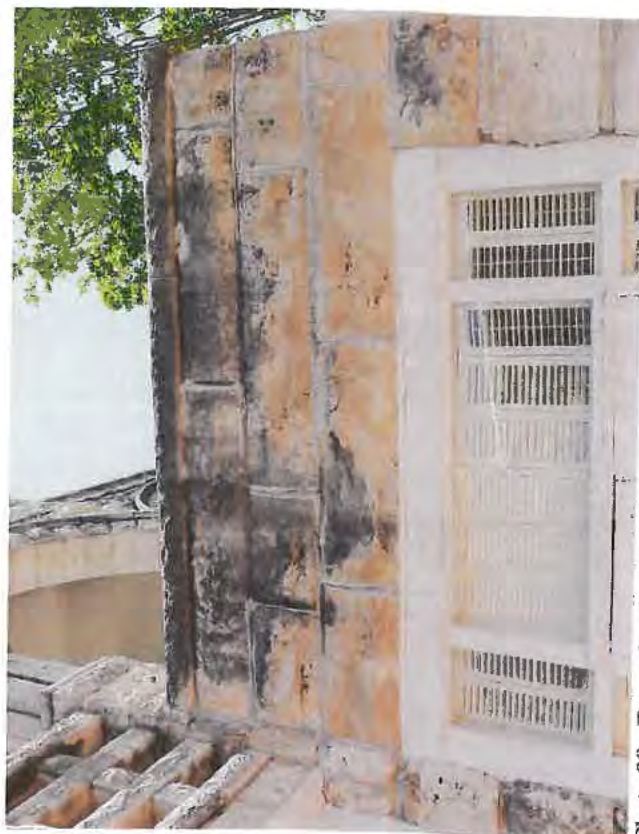
Photo 39: Example of caulk used to seal mortar joints.
